#### 5.7.4 Global Collapse of WTC 7

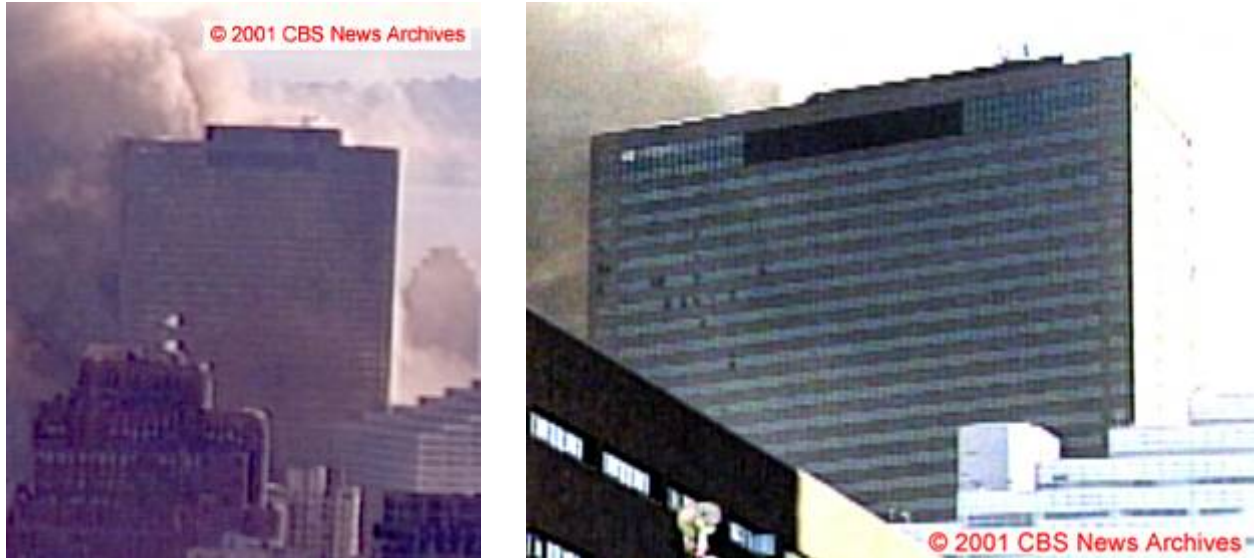
Figure 5–199 shows the north face 5.0 s after the east penthouse began moving downward. These two frames were taken from the Camera 2 long distance and Camera 3 West Street views. The time is 1.5 s after the corresponding views shown in Figure 5–197. There have been relatively minor changes in the appearance of the north face over this period. In the Camera 3 shot, it can be seen that additional glass has broken out of windows on the east side of the face. Open windows are visible at multiple locations from the 37<sup>th</sup> floor to the 43<sup>rd</sup> floor. The light coming through the open roof is apparent for windows on the 46<sup>th</sup> and 47<sup>th</sup> floors. In the longer distance view, the top of the tear-drop shaped light area that was observed moving down the north face is just visible above the buildings in the foreground. Most of the shape has already moved out of view. No other major visible changes were evident over the 1.5 s period.

**Figure 5–199. Cropped frames from the Camera 2 video clip in Figure 5–185 and the Camera 3 video clip in Figure 5–186, showing the north face of WTC 7 5.0 s  $\pm$  0.1 s after the east penthouse began to move downward.**

The intensities have been adjusted.

Figure 5–200 shows views of the north face, shot by Cameras 2 and 3, 0.6 s after this motion was first detectable. Comparison of the Camera 3 shot with the corresponding view in Figure 5–199 shows that the top of the north screenwall has moved downward on the east side. This is most easily seen by noting the variation in the height of the screenwall above the top of the north face parapet. In the more distant Camera 2 shot, the line running along the top of the north screenwall and the west penthouse appears to be slanted downward toward the east.
