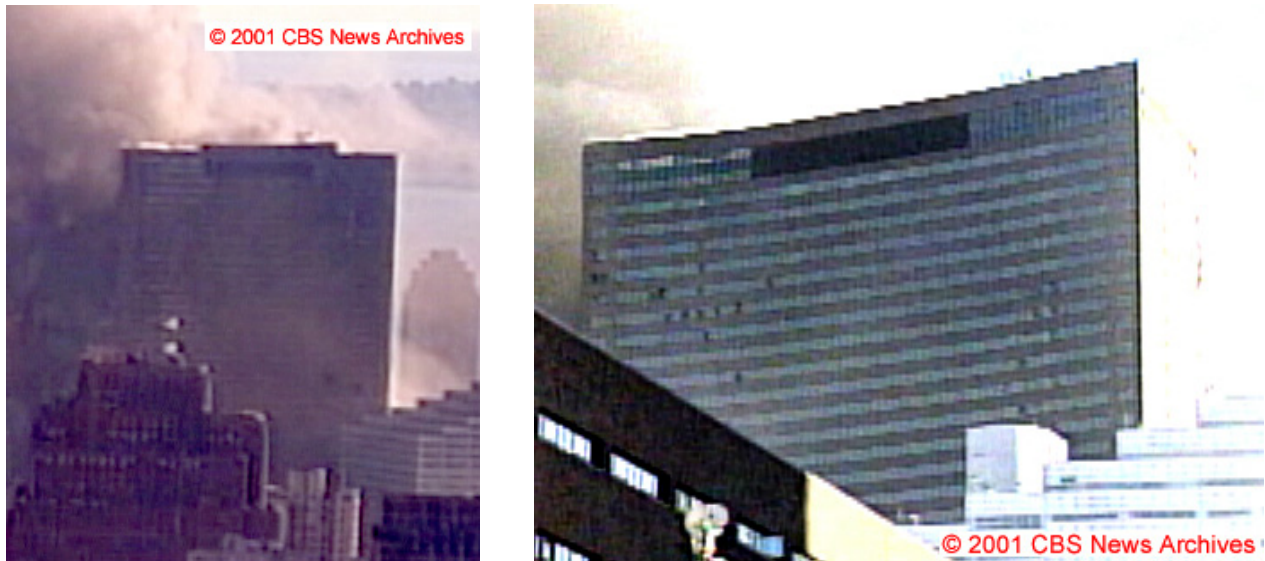
**Figure 5–202. Cropped frames from the Camera 2 video clip in Figure 5–185 and the Camera 3 video clip in Figure 5–186, showing the north face of WTC 7 8.1 s  $\pm$  0.1 s after the east penthouse began to move downward.**

The intensities have been adjusted.

Camera 2 and Camera 3 views of the north face of WTC 7 recorded 0.9 s after those in Figure 5–202, i.e., 9.0 s after the east penthouse began to move, are shown in Figure 5–203. By this time, the entire north face that is visible above the foreground buildings was clearly falling as a unit. By counting the visible floors above the foreground building in the view from West Street, it was found that WTC 7 had fallen nearly two stories in the 2.1 s since the global collapse started. The façade damage on the west side of the face has increased and seems to extend over most of the visible floors between Columns 54 and 55. What appears to be dust has begun to flow from the open windows. A few additional windows have opened near the center of the face since the frame in Figure 5–202 was taken. The distribution of open east-side windows looks similar at the two times. The rotation of the east edge of the north face has become more evident, and a distinct kink has begun to develop just to the left of the east end of the louvers on the 46<sup>th</sup> and 47<sup>th</sup> floors. This location is close to perimeter Column 47.
