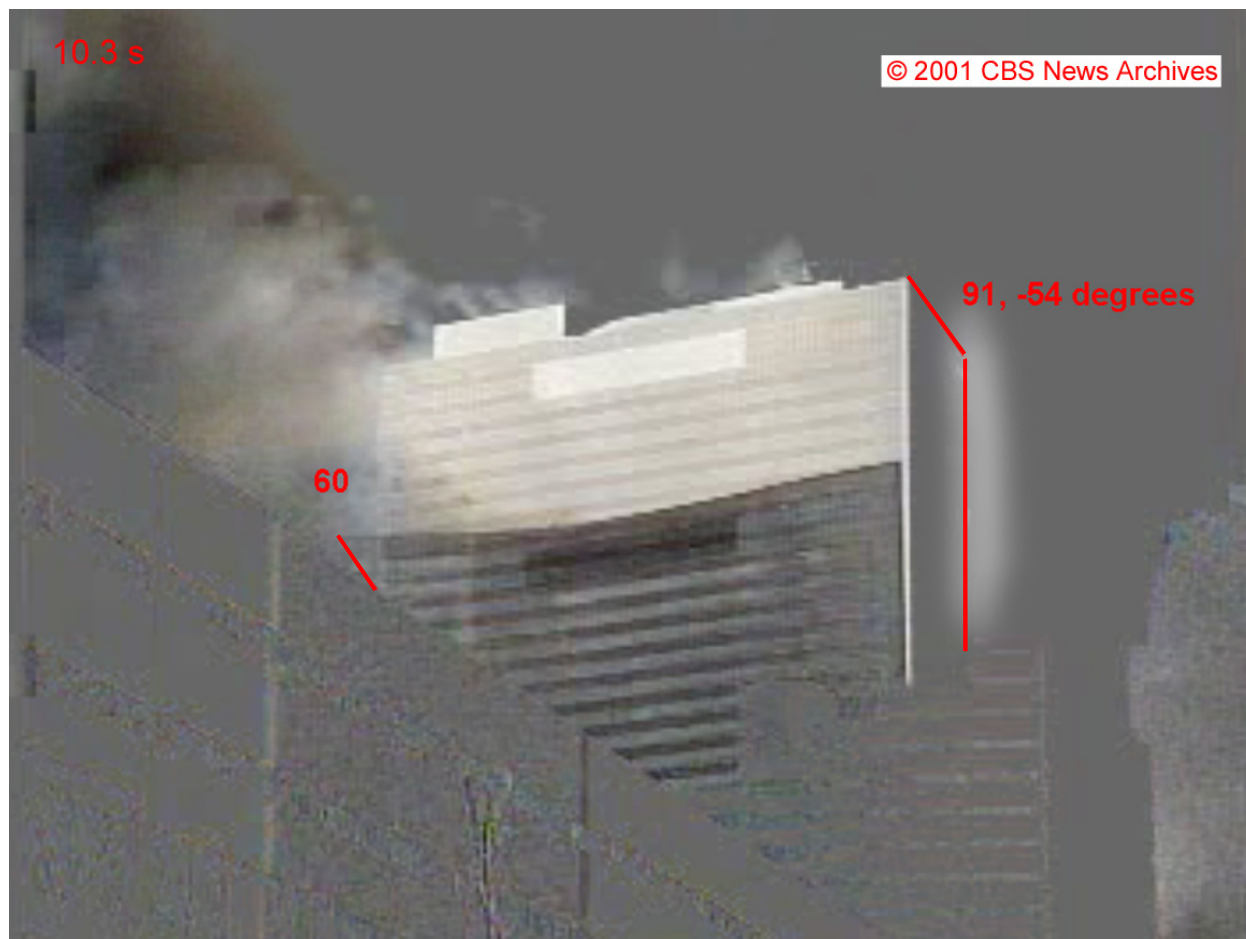
The extent of the northeast edge motion was estimated using the Camera 3 video frame in Figure 5–206, at which time the top of the building had descended about seven stories. The two red lines on the right trace the west roofline and the southwest edge of WTC 7. The red line at the left is parallel to the west roofline and passes through the top of the northeast corner of the descending roofline. A geometric calculation was performed, involving the angle between these two lines, the dimensions of the building, the distance between the camera and the building, and the viewing angles of the northeast and southwest corners. The calculation led to an estimate that, at this point in the collapse, the top of the northeast corner roofline was displaced  $11 \text{ m} \pm 3 \text{ m}$  from its original footprint. In combination with observations from Figure 5–204, it is possible to determine that the motion was primarily due north.

**Figure 5–206. Heavily processed difference frame from the camera 3 video, used to estimate the lateral distance the northeast corner of WTC 7 moved from its original footprint during the collapse.**

It was recorded 10.3 s after the east penthouse began to move down.
