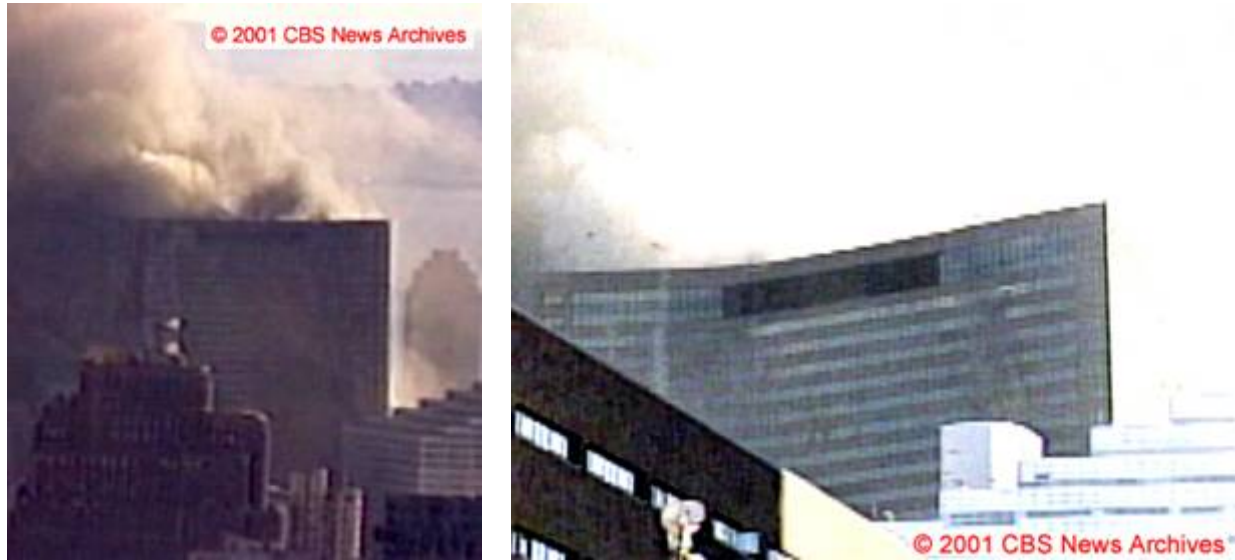
**Figure 5–208. Cropped frames from the Camera 2 video clip in Figure 5–185 and the Camera 3 video clip in Figure 5–186, showing the north face of WTC 7 10.0 s  $\pm$  0.1 s after the east penthouse began to move downward.**

9.2 s after the east penthouse started moving. The kink near Column 47 is still prominent. The dust plume being forced from the roof opening on the east side of the building is visible. In the distant view, the entire west penthouse has disappeared below the north wall parapet. This took place around 9.3 s. A dust cloud, similar to that being ejected from the opening in the roof on the east side, has begun to form just to the west of the center of the north face. This suggests that the roof has also opened at this location.

The intensities have been adjusted.
