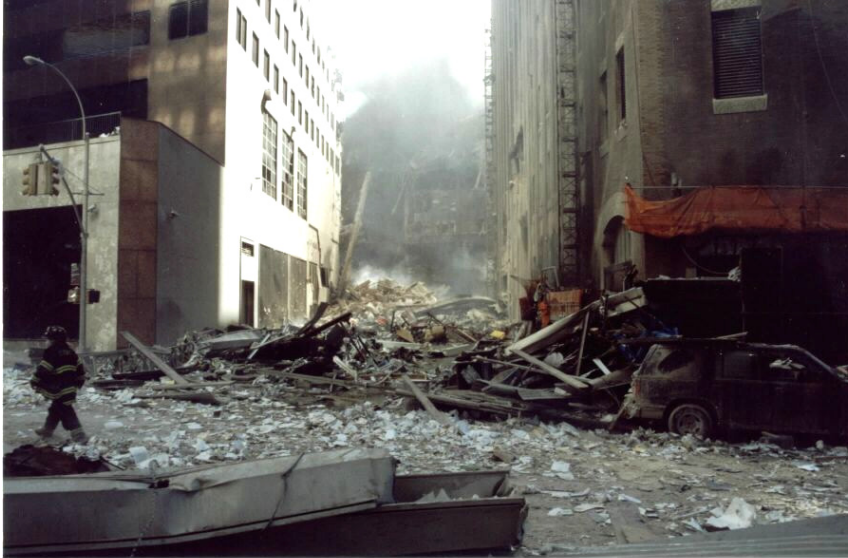
**Figure A-4. Northwest corner of the Con Edison substation (building on left), showing light damage from WTC 1 debris. (Photo taken sometime in the afternoon on Sept. 11, 2001.)**
