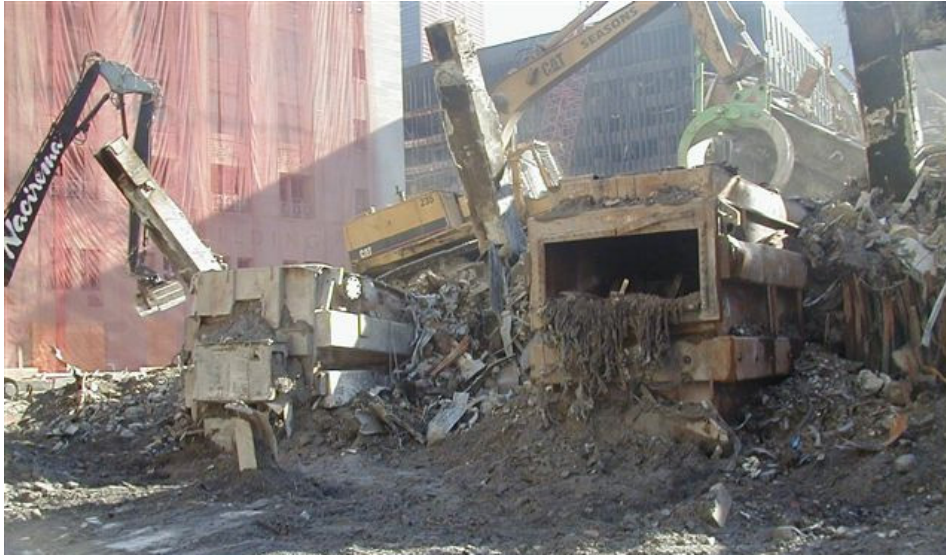
**Figure A-8.**  
Photograph taken  
in mid-October,  
2001, showing  
Con Edison  
transformers #6  
and #1 uncovered  
from debris pile of  
WTC 7.

Transformer #7 (or possibly #5) is barely visible within the white box in Figure A-9. This transformer and the other three depicted in Figures A-7 and A-8 were not salvageable and were discarded.

NIST was unable to determine whether the thermal damage to the transformers occurred due to electrical overheating, due to a fire in the substation after the SCADA logs were terminated around 4:33 p.m., or due to burning within the rubble pile subsequent to the collapse of WTC 7.

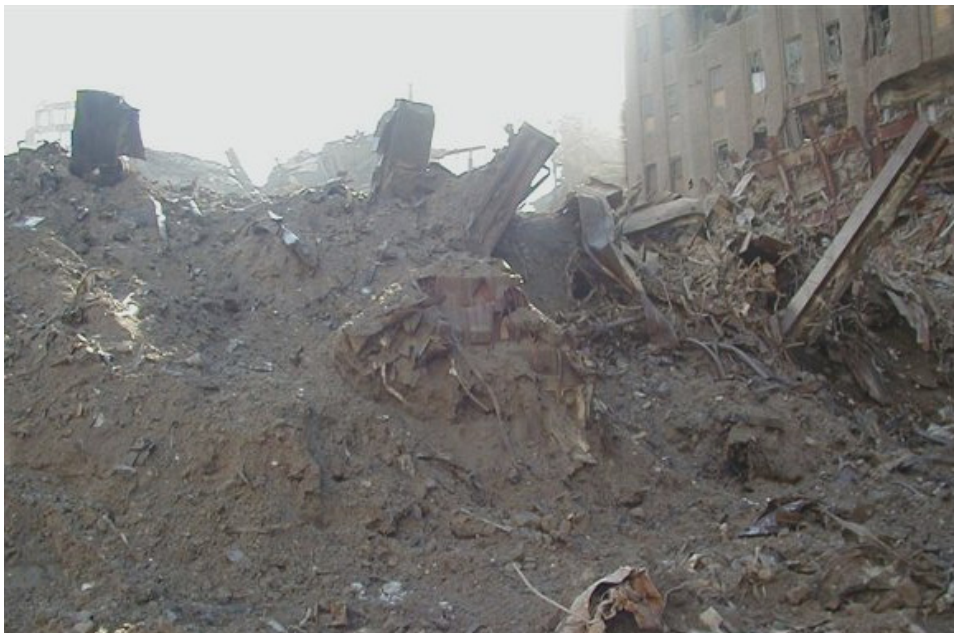
**Figure A-9.**  
Con Edison  
transformer #7  
(or #5) uncovered  
from debris pile of  
WTC 7; photo  
taken mid-  
October, 2001.
