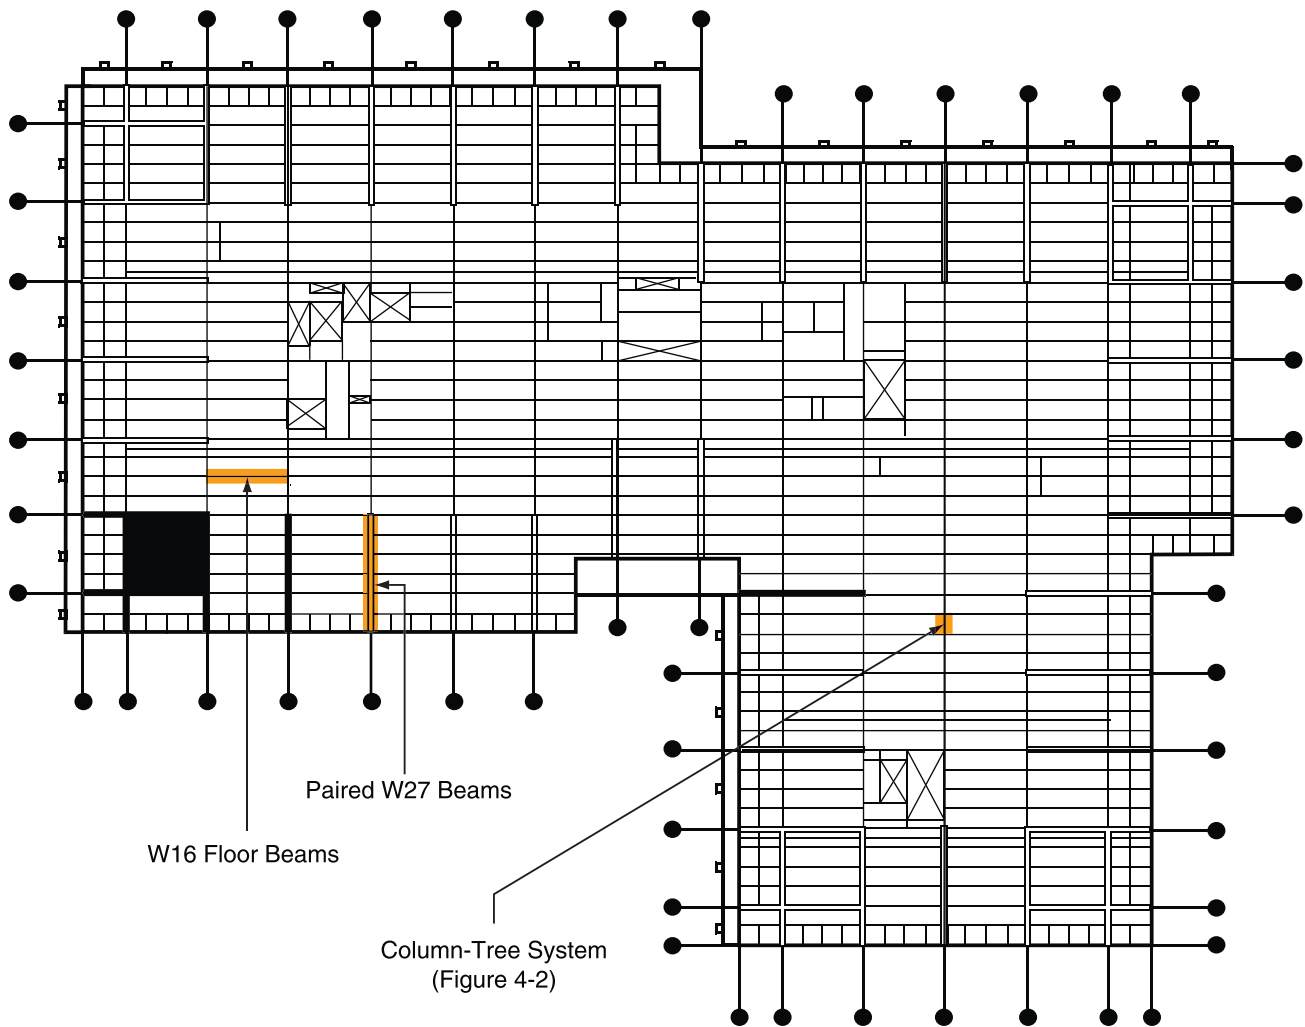
Figure 4-1 Typical floor plan for WTC 5 (Worthington, Skilling, Helle & Jackson 1968).
