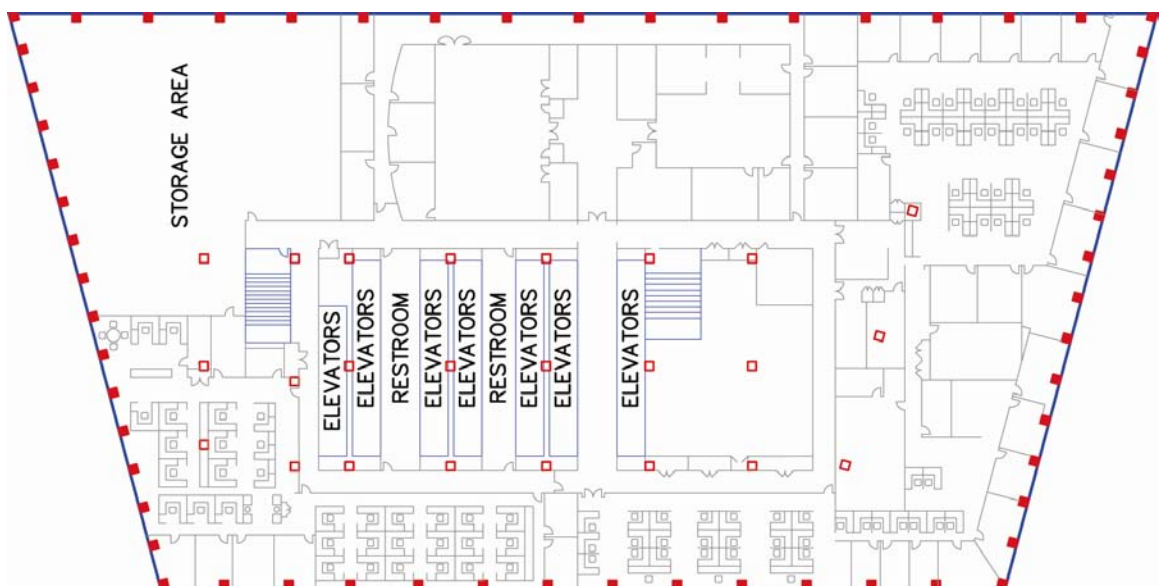
**Figure 3–8. Schematic of Floor 13.**

testimony rooms on the northern portion of the east side of the floor and a storage room at the northwest corner. The testimony rooms were sparsely furnished, with just a table and a few chairs.

NIST drawing derived from material provided by the U.S. Securities and Exchange Commission
