# 6 *Bankers Trust Building*

## 6.1 Introduction

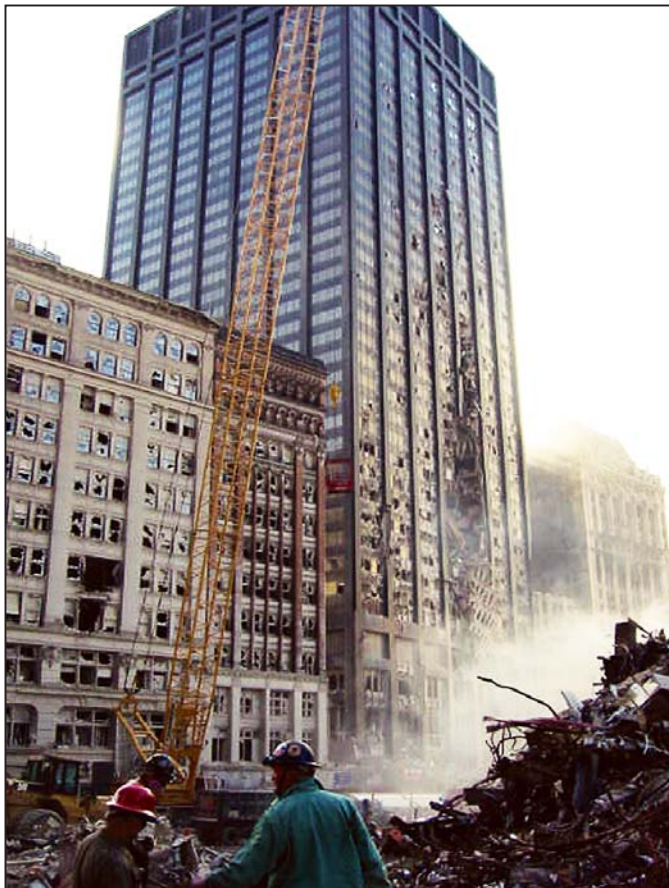
The Bankers Trust building at 130 Liberty Street, also referred to as the Deutsche Bank building, withstood the impact of one or more pieces of column-tree debris raining down from the collapsing south tower (WTC 2). Although the debris sliced through the exterior façade, fracturing spandrel beam connections and exterior columns for a height of approximately 15 stories, the building sustained only localized damage in the immediate path of the debris from WTC 2 (hereafter referred to as the impact debris) (Figures 6-1 and 6-2). There were no fires in this building. The ability of this building to sustain significant structural damage yet arrest the progression of collapse is worthy of thorough study. Unlike WTC 1, 2, and 7, which collapsed completely, the Bankers Trust building provided an opportunity to analyze a structure that suffered a moderate

*Figure 6-1  
North face of Bankers Trust building with impact damage  
between floors 8 and 23.*
