## 7.4 30 West Broadway

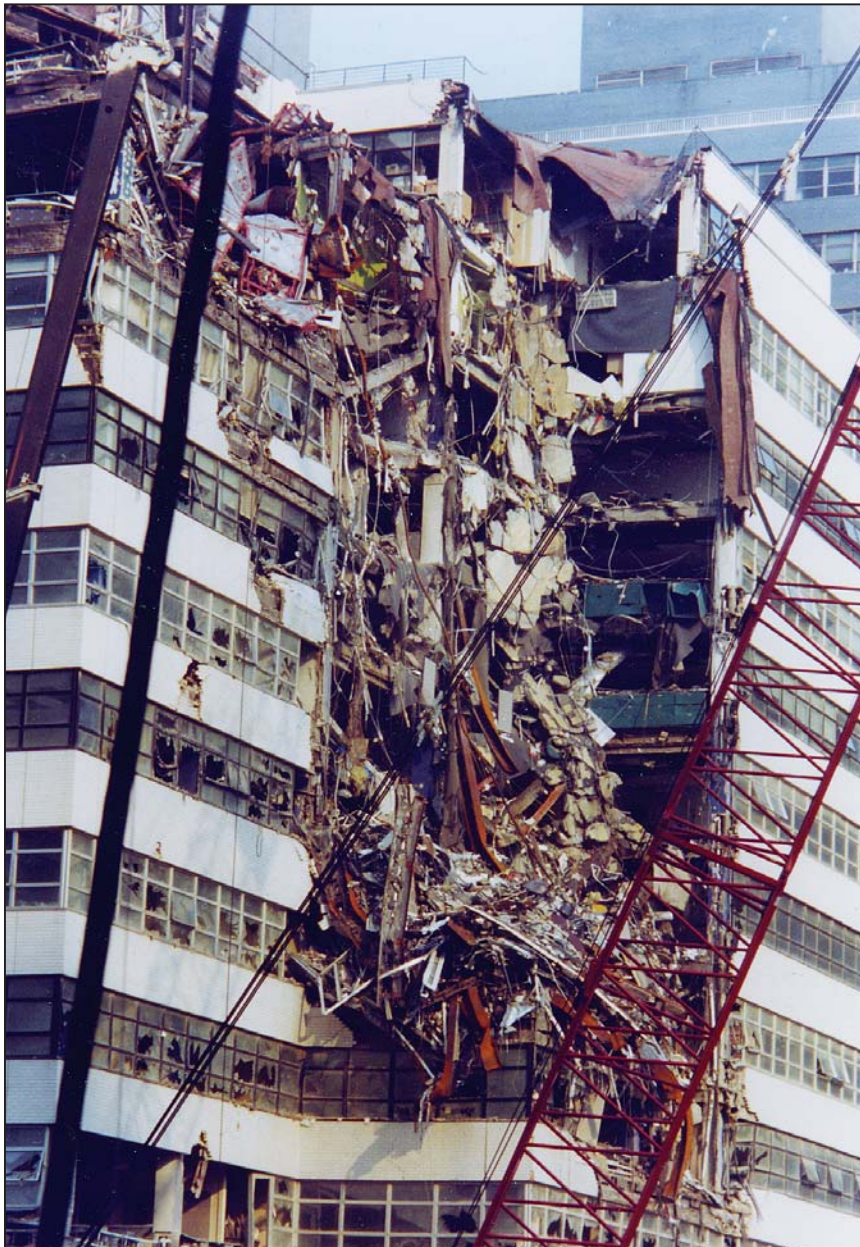
The southern half of the west façade and most of the south façade were severely damaged or destroyed. The south face of the building suffered structural damage in the exterior bay from impact by large debris from WTC 7 (Figure 7-13). There was no damage to the east and north faces of the building, and no fire in the building, even though there was a substantial fire in WTC 7.

*Figure 7-13*  
*30 West Broadway – south façade, 6th floor to roof, looking northeast.*
